REPORT NO. CG-D-2-77

LIGHTWEIGHT LIGHTED BUOY DEVELOPMENT  
FOR USE AS DISCREPANCY NAVAIDS

W. E. Colburn, Jr.  
and  
W. R. Thompson

December 1976

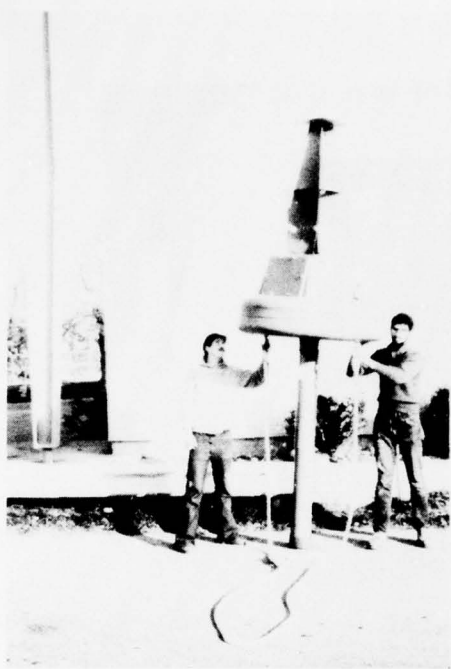
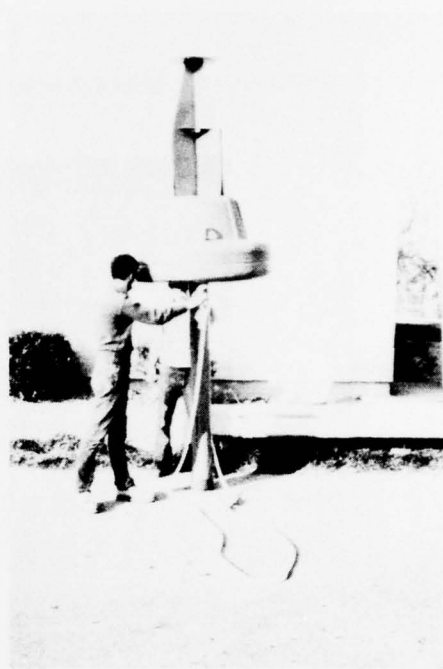
FIGURE 2

THE MAXIMUM AND MINIMUM DAYMARK PROJECT AREAS OF  
THE NUN AND CAN VERSIONS OF THE PPSWDB BUOY

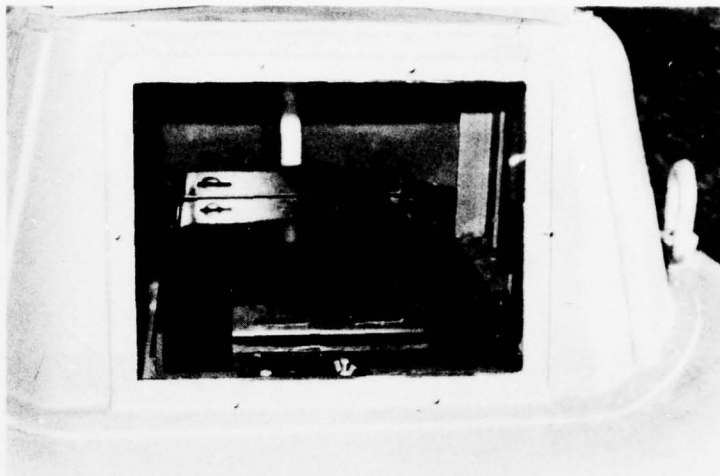
FIGURE 3

THE IMPROVED BATTERY COMPARTMENT ON THE PRE-PROTOTYPE BUOYS WITH THE STANTIONS INSIDE THE COMPARTMENT TRANSFERRING THE DAYMARK LOAD DIRECTLY TO THE HULL, THE DOUBLER PLATE ON THE COMPARTMENT'S TOP SURFACE, AND THE PVC ANGLE EXTENDING TO THE EDGE OF THE DOUBLER PLATE.

A vented battery compartment is fixed to the top of the flotation collar and contains a removable battery tray. Several types of batteries can be attached to the tray and the tray can then be inserted into the battery compartment. A rectangular door closes the battery compartment and this door is held in place by a series of nuts around its perimeter. The improved battery compartment is shown in Figure 3.

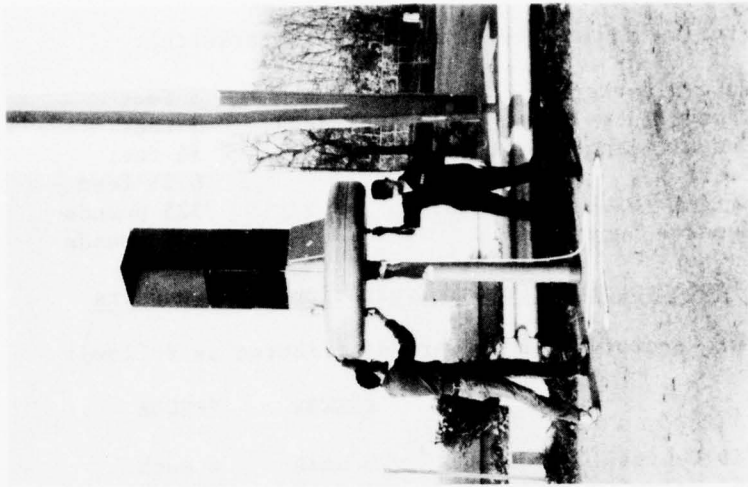
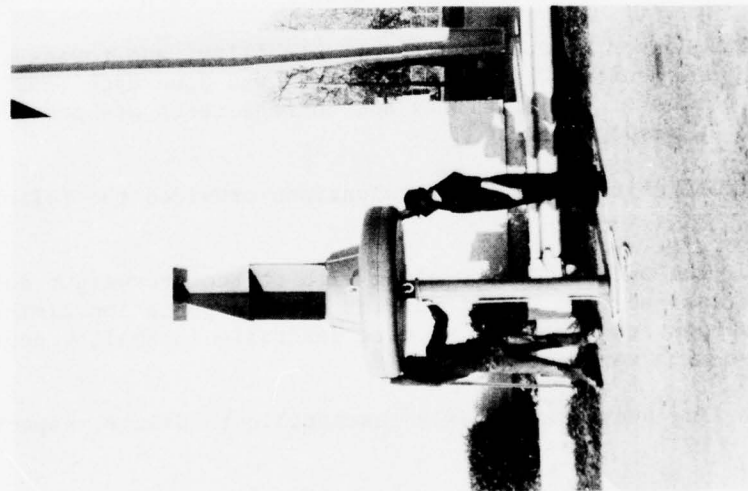
FIGURE 4  
NUN AND CAN VERSIONS OF THE PPEWDB BUOY

This buoy is the same as the PPSWDB with the exception of size. The flotation collar is five feet in diameter and the center tube extends six feet below the flotation collar (Figure 4). The radar reflector/daymark is larger than on the PPSWDB buoy.

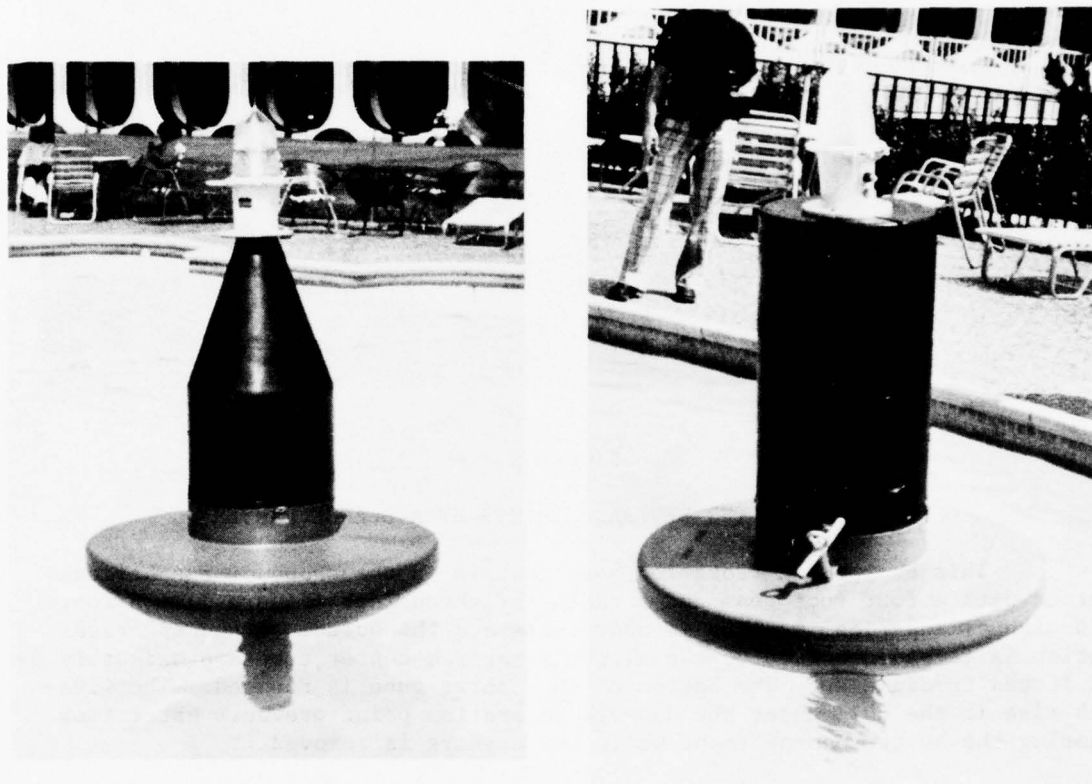
FIGURE 5

WGDB BUOY WITH NUN AND CAN DAYMARKS

This buoy is designated WGDB because of its wine glass hull shape. The WGDB sheltered water discrepancy buoy was designed from scratch using the knowledge gained from the previous discrepancy buoys and fast water buoys. The NUN and CAN versions of this buoy are shown in Figure 5.

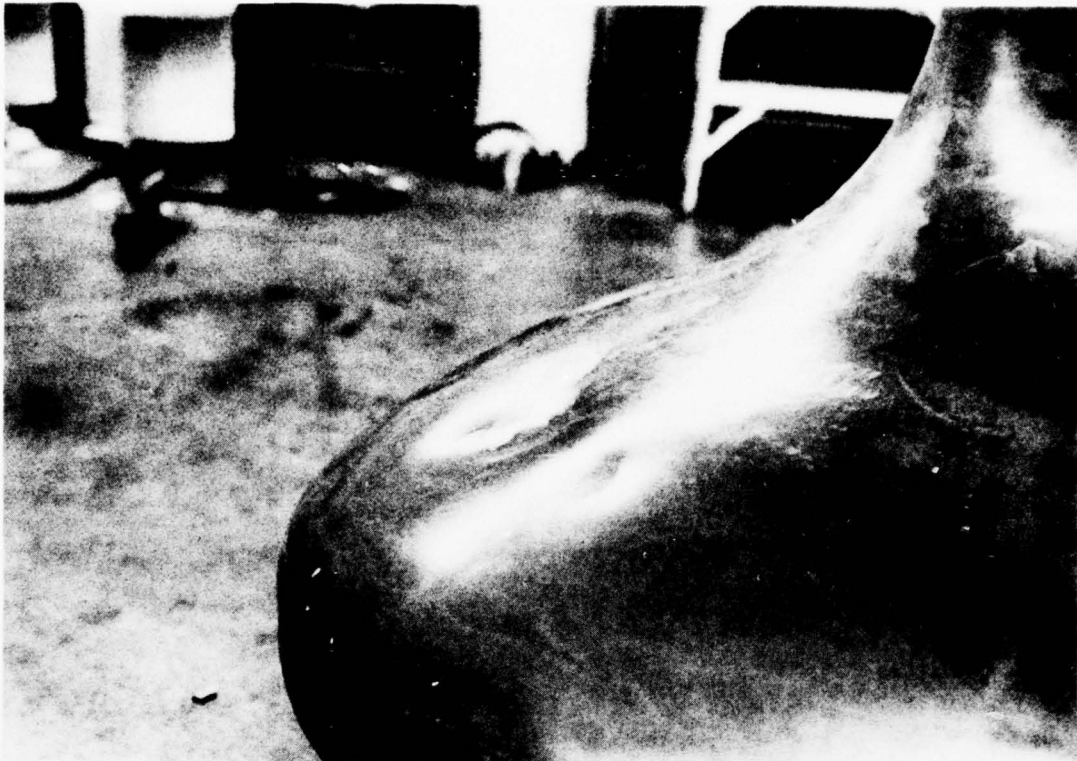
FIGURE 6

WGDB HULL AFTER SEVERAL STRIKES BY A SLEDGE HAMMER

The objective of this design was to develop a buoy that would be more durable than the previous buoys (Figure 6), have better performance in current (Section 5.2.3) and waves, have a daymark that fits within the guidelines of daymark shape (Section 5.1.1) and cost less than the previous designs (\$327 versus \$790 and \$690 for the PPSWDB and PPEWDB respectively).

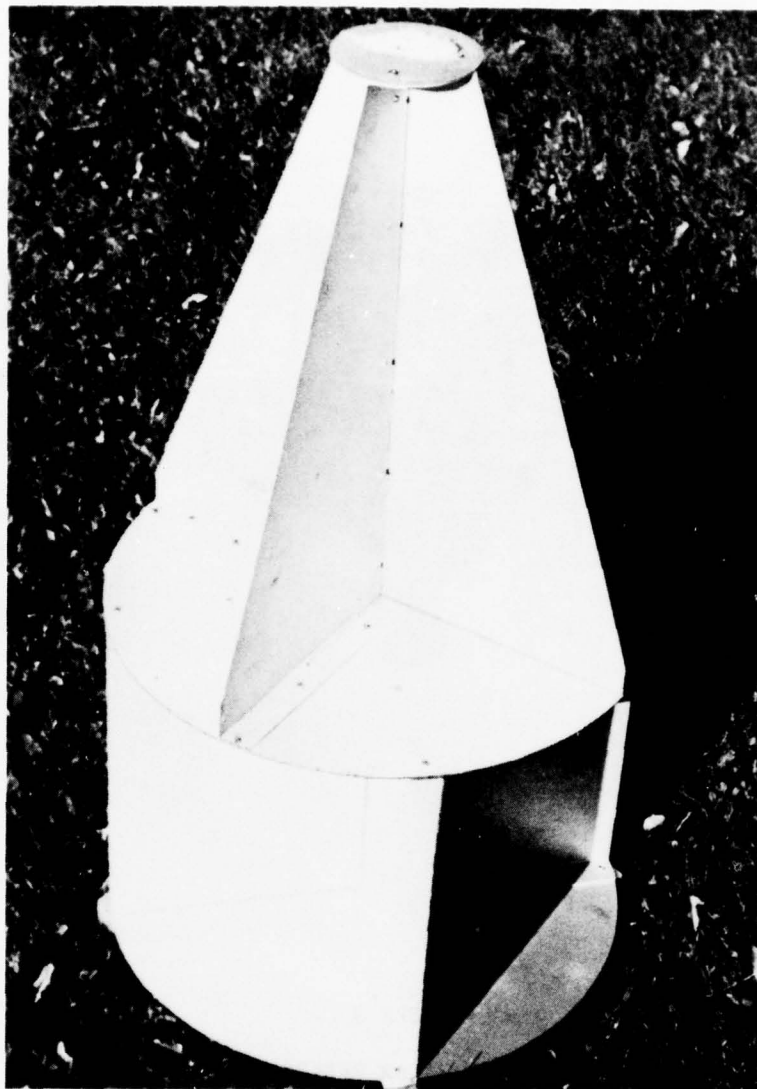
FIGURE 8

WGDB BUOY RADAR REFLECTOR

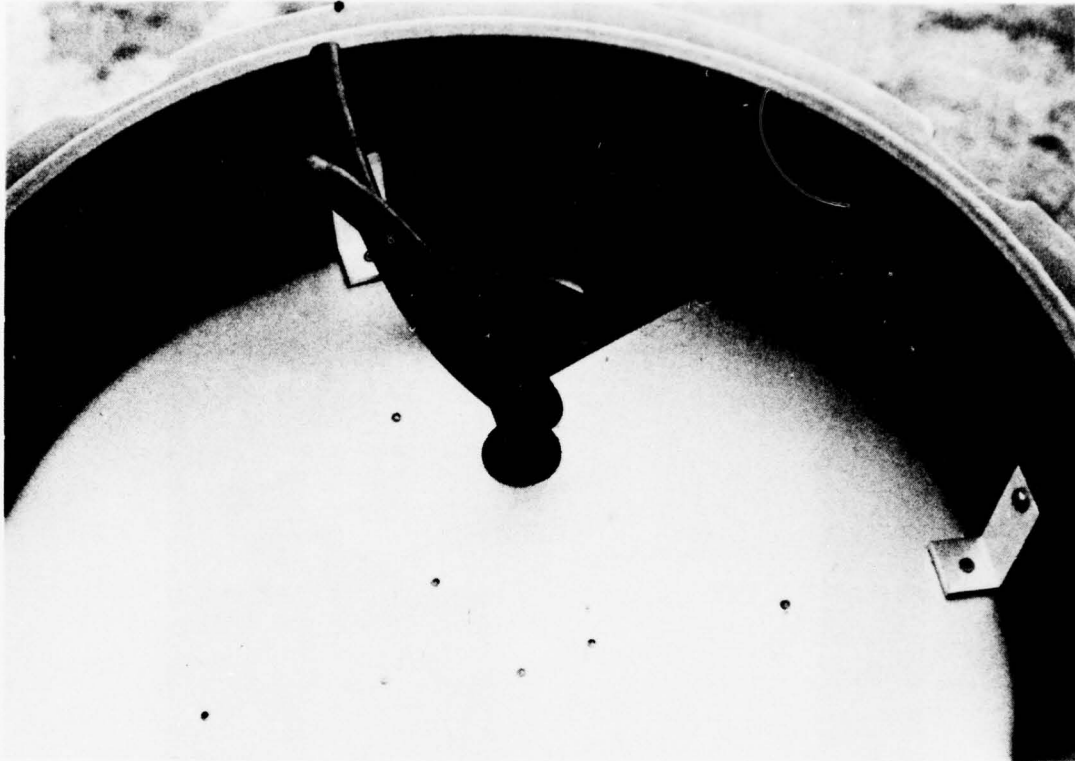
FIGURE 9

THE ATTACHMENT OF THE RADAR REFLECTOR IN EITHER THE  
NUN OR CAN (THE WIRE LEADS THROUGH A STUFFING TUBE  
IN THE DAYMARK AND THEN TO THE LANTERN.

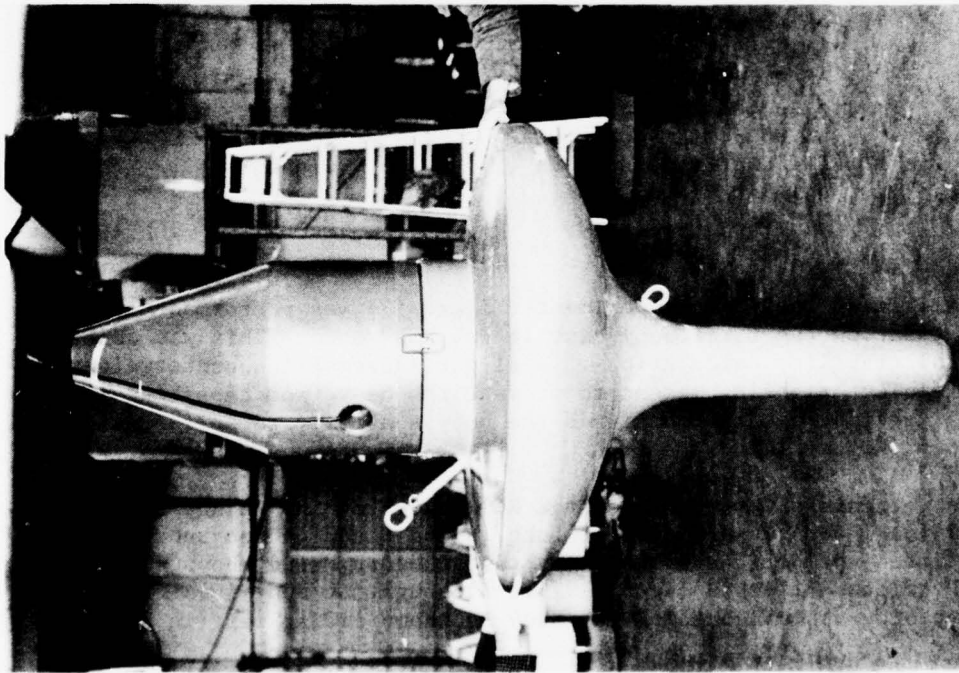
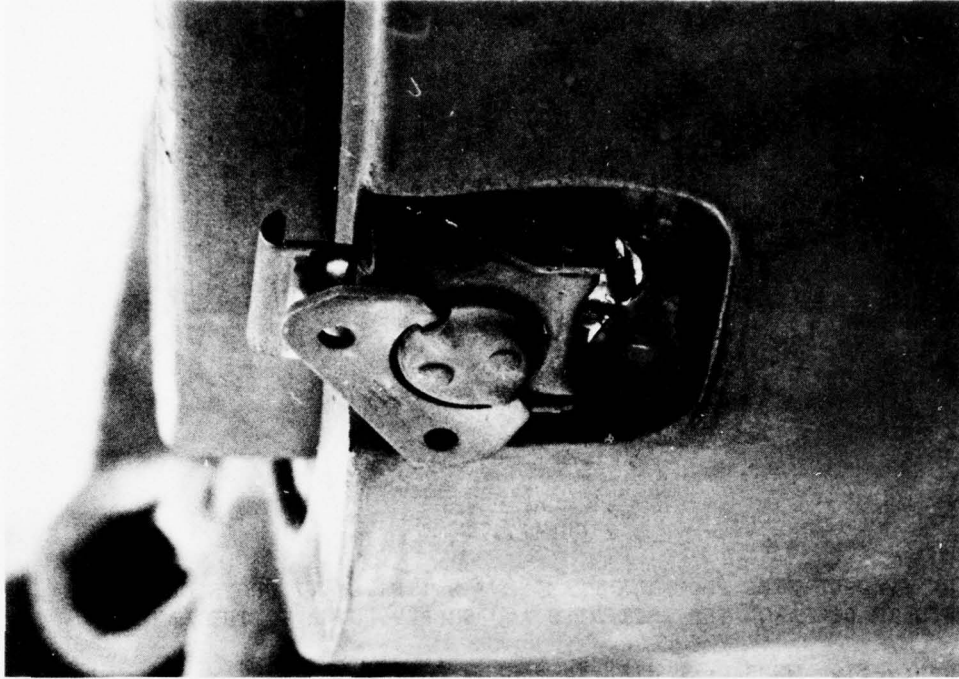
FIGURE 10

THE NUN OR CAN DAYMARK IS ATTACHED ONTO THE HULL (a)  
BY FOUR RECESSED LATCHES (b) HULL PART SHOWN

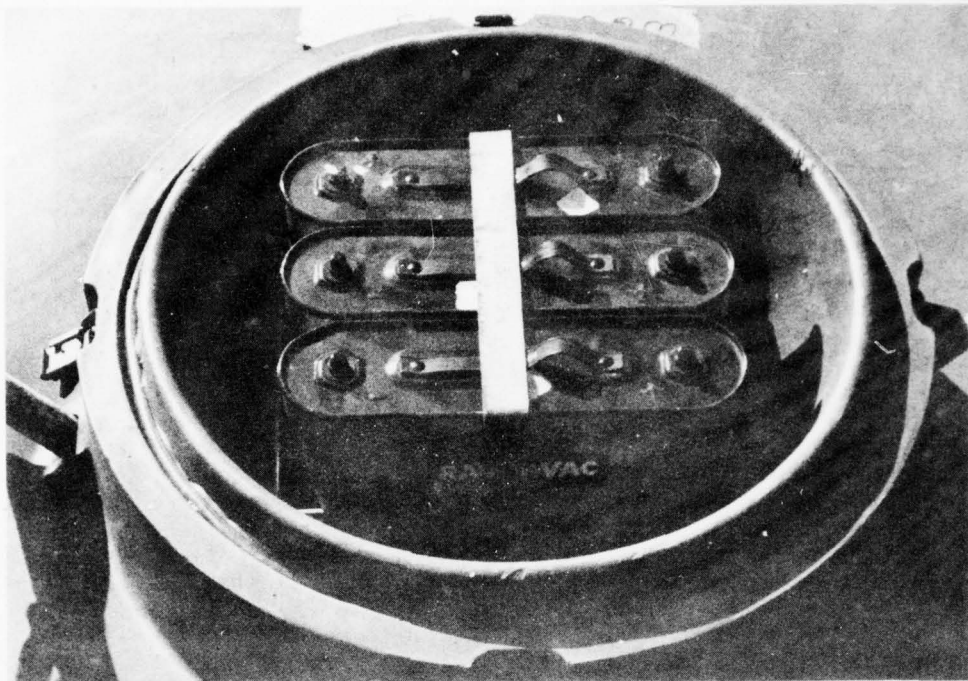
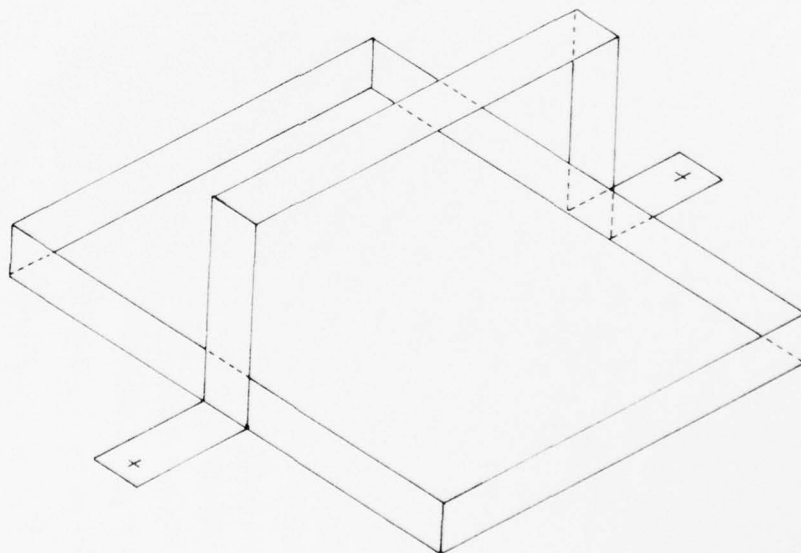
FIGURE 12

BATTERIES ((a), HOT SHOT BATTERIES ARE SHOWN HERE) ARE LOCATED UNDER THE DAYMARK AND ARE HELD IN PLACE WITH THE HOLDDOWN SHOWN (b) OR BY A STRAP.

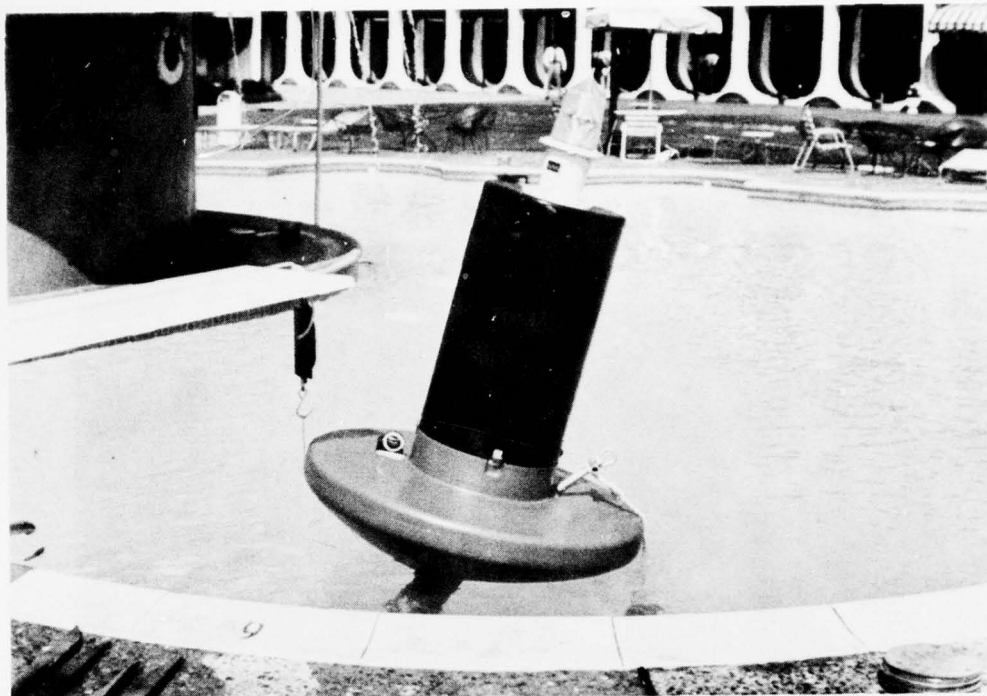
FIGURE 13

INCLINING EXPERIMENT OF THE FIRST WGDB BUOY TO VERIFY STABILITY CALCULATIONS.

An initial inclining experiment (Figure 13) was performed near the fabricators plant on the first buoy cast in the WGDB mold. This was done to verify initial stability calculations. A slight increase in counterweight provided sufficient righting moment to prevent the buoy from capsizing in 40-knot winds. The testing also confirmed the buoy's ability to self-right under all conditions (Figure 14).

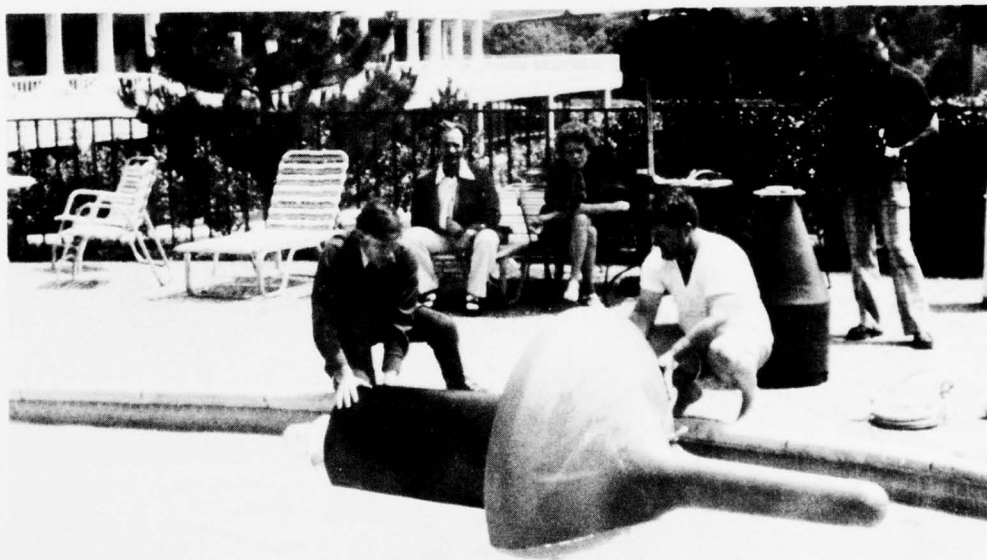
FIGURE 14

WGDB SELF-RIGHTING TEST SHOWED THAT THE BUOY WOULD NOT REMAIN CAPSIZED UNDER ANY CONDITIONS.

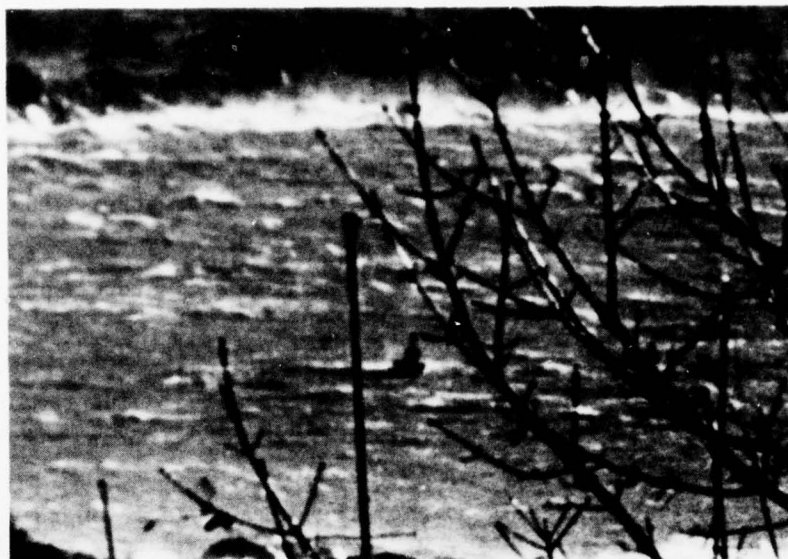
FIGURE 15

A WGDB BUOY RIDING WELL IN A 40-KNOT STORM

Deployments of two buoys at the R&D Center's Pine Island test site plus an additional two buoys placed in Long Island Sound in conjunction with a NAVAID positioning project have been very satisfactory. The buoys survived the effects of Hurricane Belle in August 1976. Although the buoy is difficult to view in the photograph, Figure 15, the buoy is shown riding well in a 40-knot storm.

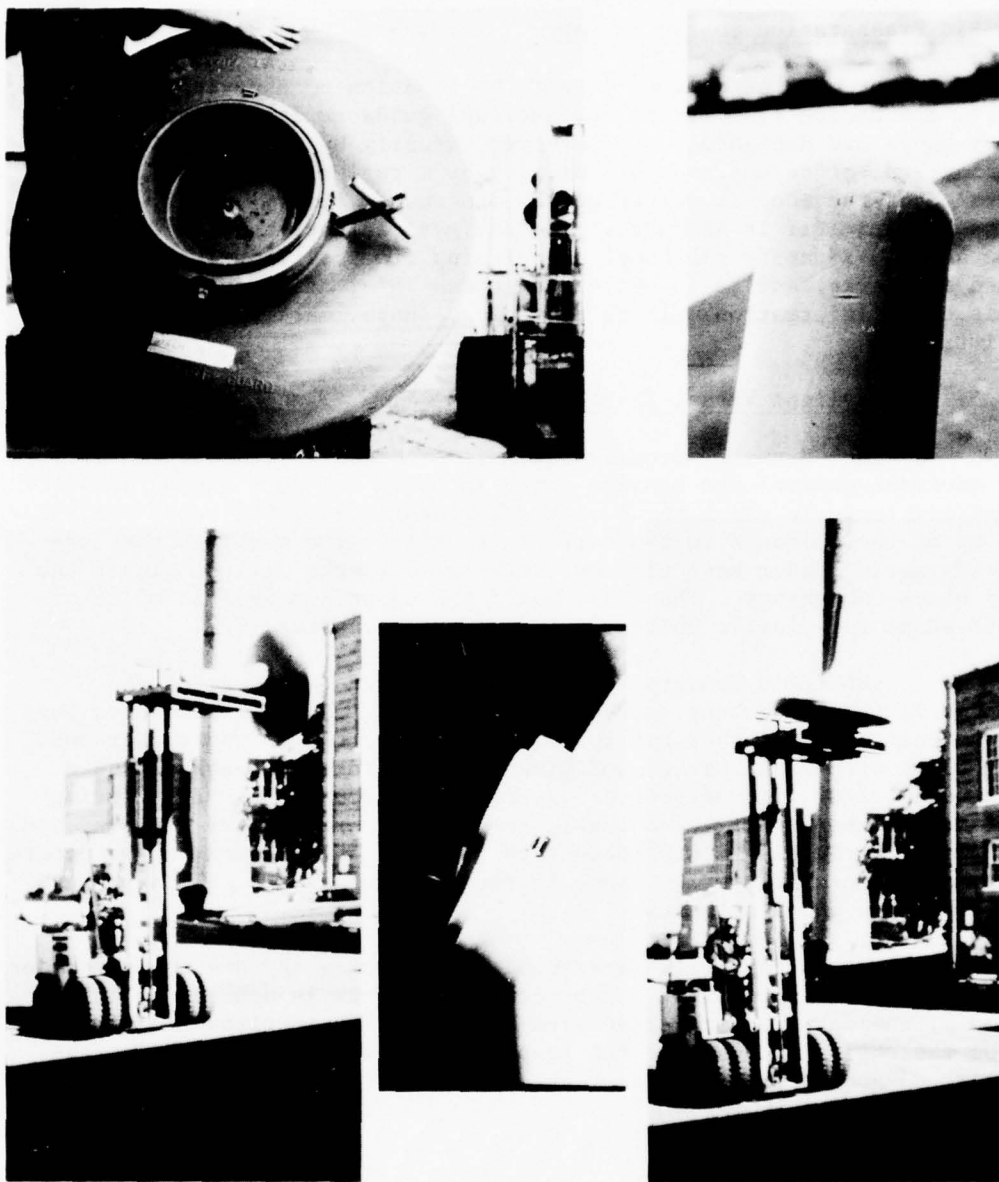
FIGURE 16

#### DESTRUCTIVE TESTING OF THE WGDB BUOY

The buoy was dropped from a loading dock (a) onto its gunwale and on the counterweight tube (b) with only minor distortion and abrasion damage. Then, it was dropped from a forklift (c) onto its top (d) with limited distortion (daymark still fits), and onto its counterweight tube from the forklift (e) with minimal damage. The buoy is still operational.

- a. Rolling the buoy hull from a loading dock (Figure 16a - no damage).
- b. Throwing the hull off the loading dock such that it would land on the counterweight tube (Figure 16b - some minor distortion and abrasion).
- c. Dropping the hull from a forklift (Figure 16c) onto its top (Figure 16d -distortion but the daymark still fits).
- d. Dropping the hull from a forklift (Figure 16e) onto its counterweight tube (more distortion than b. above but would not affect the buoy's use).
- e. Backing into the hull (upside down and against a wall) with the forklift from about 20 feet away (distortion of the deck near the points of impact but would not affect the buoy's use).

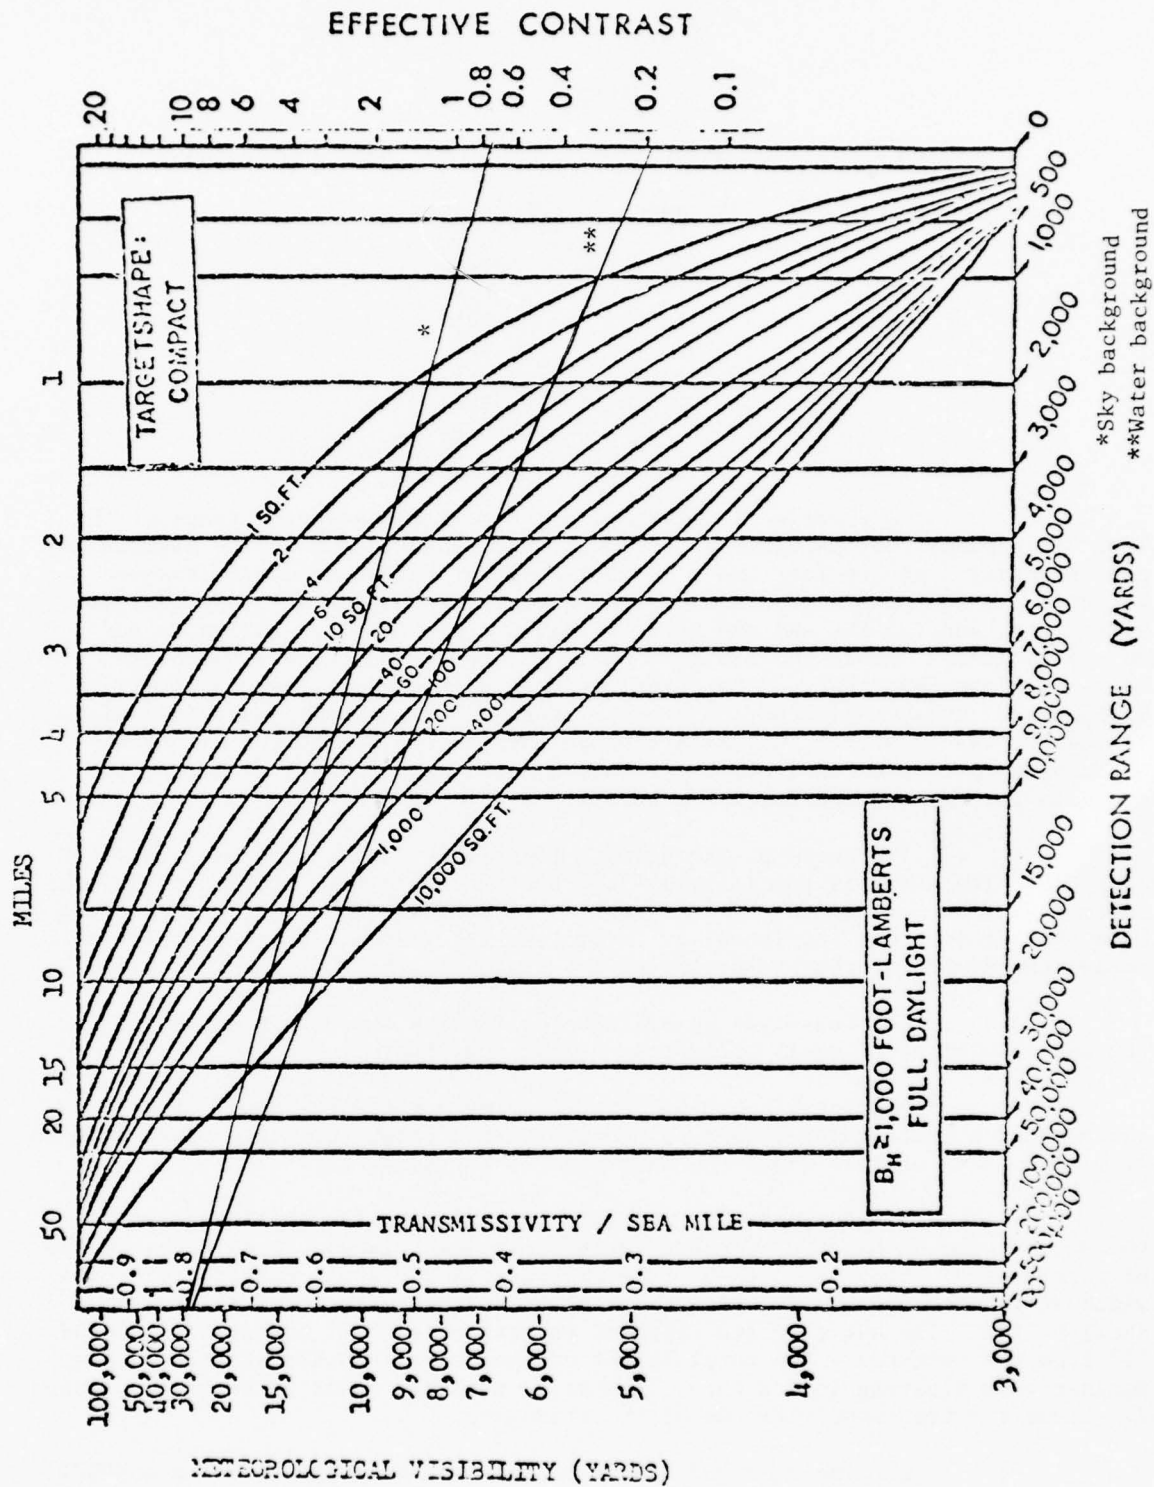
FIGURE 17  
DUNTLEY'S NOMOGRAM

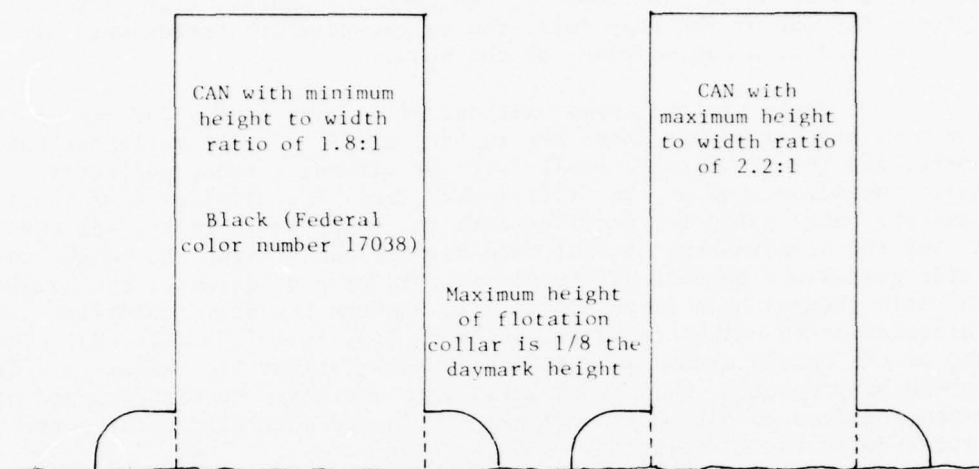
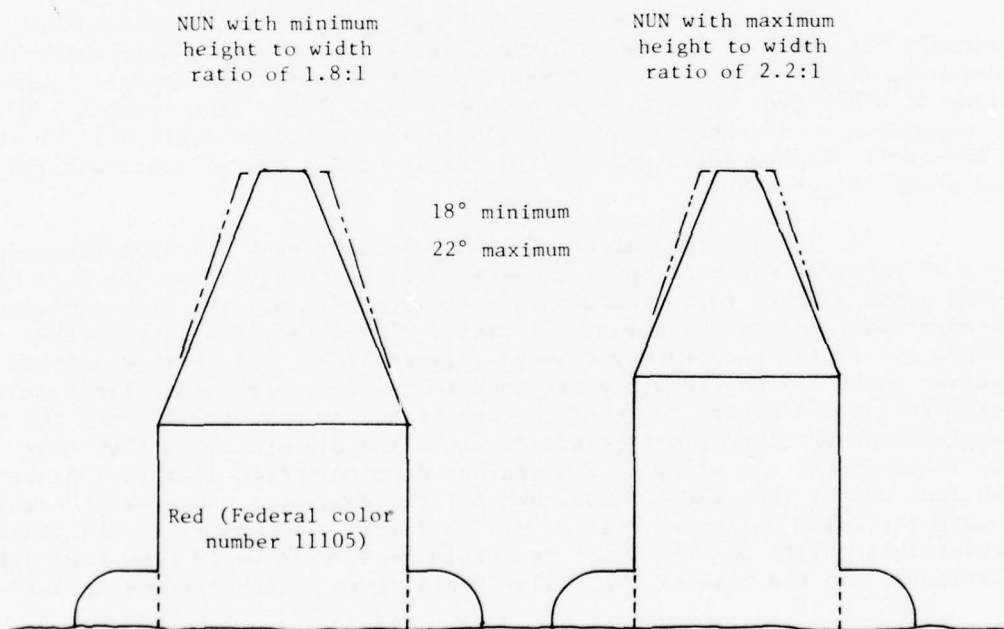
FIGURE 19

SIX METHODS OF INTERCHANGING  
RED NUN AND BLACK CAN DAYMARKS

The interpretation of the TOR requirement of the interchangeability of daymarks was that the same buoy could be changed from NUN to a CAN and visa versa without repainting, with a minimum of cost, and with a minimum of storage requirements for changeover parts. The reversible panel method developed use on the pre-prototype buoys (Figure 19b). This method allowed all changeover parts are continuously attached to the buoy preventing loss, minimizing storage and minimizing the cost,. Loss of one or more panels when the buoy was deployed would cause a non-standard, confusing daymark. The WGDB buoy design incorporated the separate NUN and CAN daymark method (Figure 19d) because it was less weight than the CAN over NUN for the same cost and storage requirement (although the radar reflector must be switched from one daymark to the other). The reversible collar was the least desirable because it would have been difficult to fabricate, and the loss of the collar would cause a non-standard daymark.

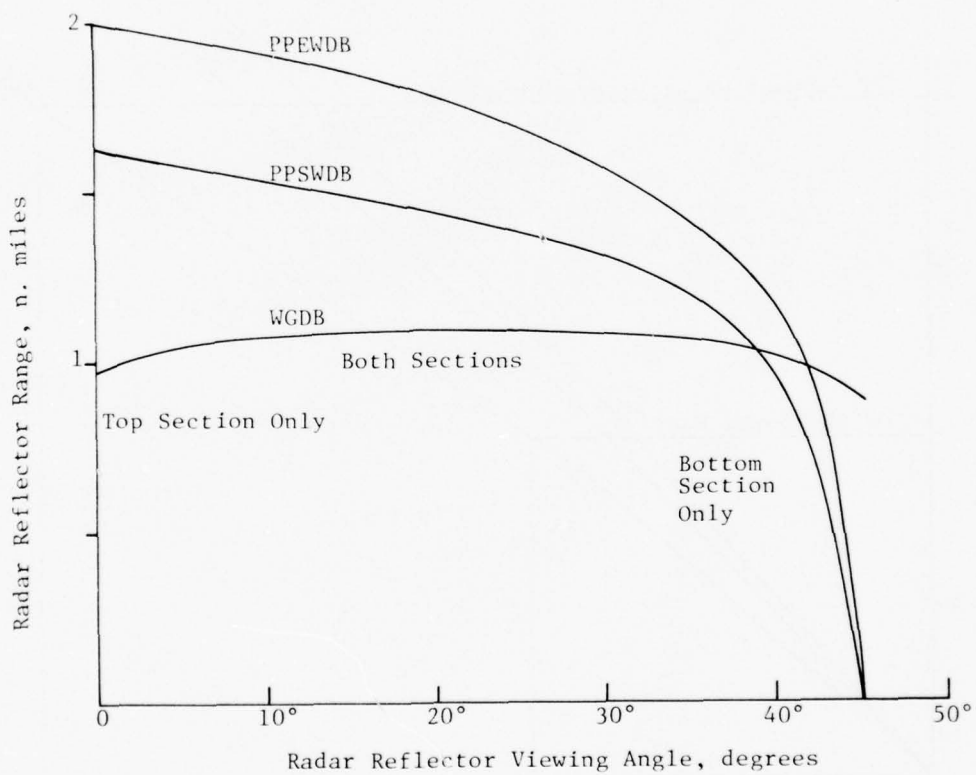
FIGURE 21

Theoretical radar range of the WGDB, PPSWDB, and PPEWDB buoys for a 3kw stereotype radar set as a function of the viewing angle (repeats beyond 45°).

Theoretical analysis to determine the minimum radar reflector size that would be required to fulfill the original TOR using a stacked bi-plane reflector of the type used in the WGDB buoy and assuming the 3kw stereotype radar set. This analysis led to the reduction in the TOR.

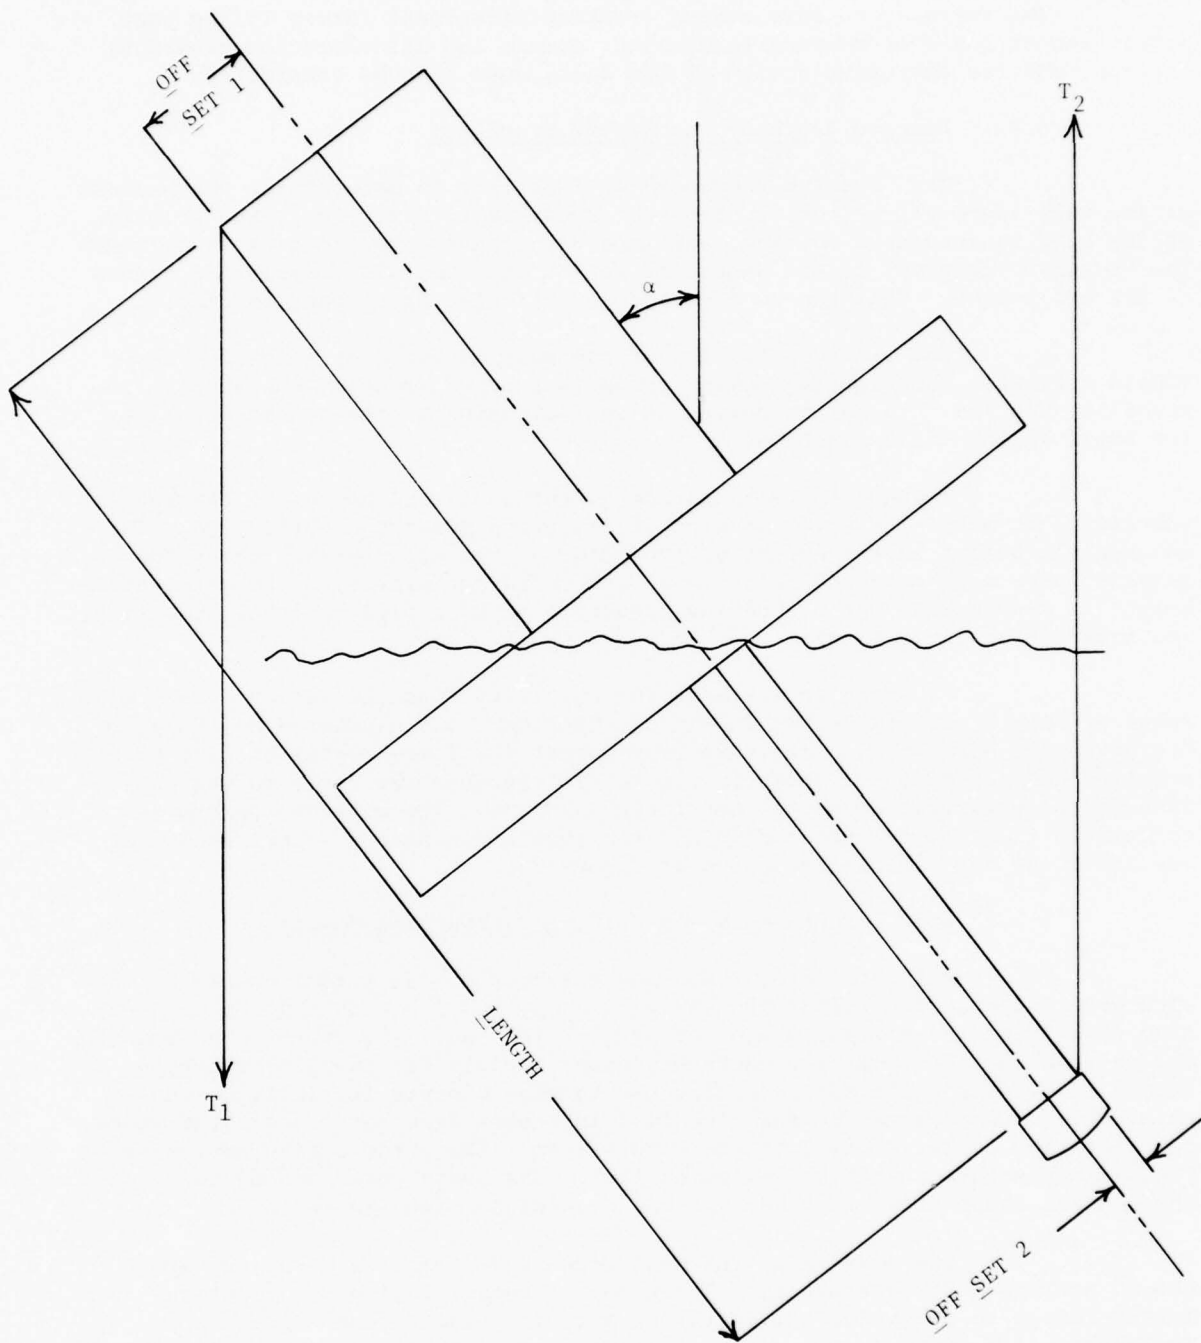
FIGURE 22

Inclining experiment method, where the righting moment is equivalent to the overturning moment. The overturning moment is induced by the "couple" with the magnitude of force being  $T_1 = T_2 = T$ , and an effective arm of  $[L \sin \alpha + (Os_1 + Os_2) \cos \alpha]$ , thus the righting moment is:  $Rm = T[L \sin \alpha + (Os_1 + Os_2) \cos \alpha]$ .

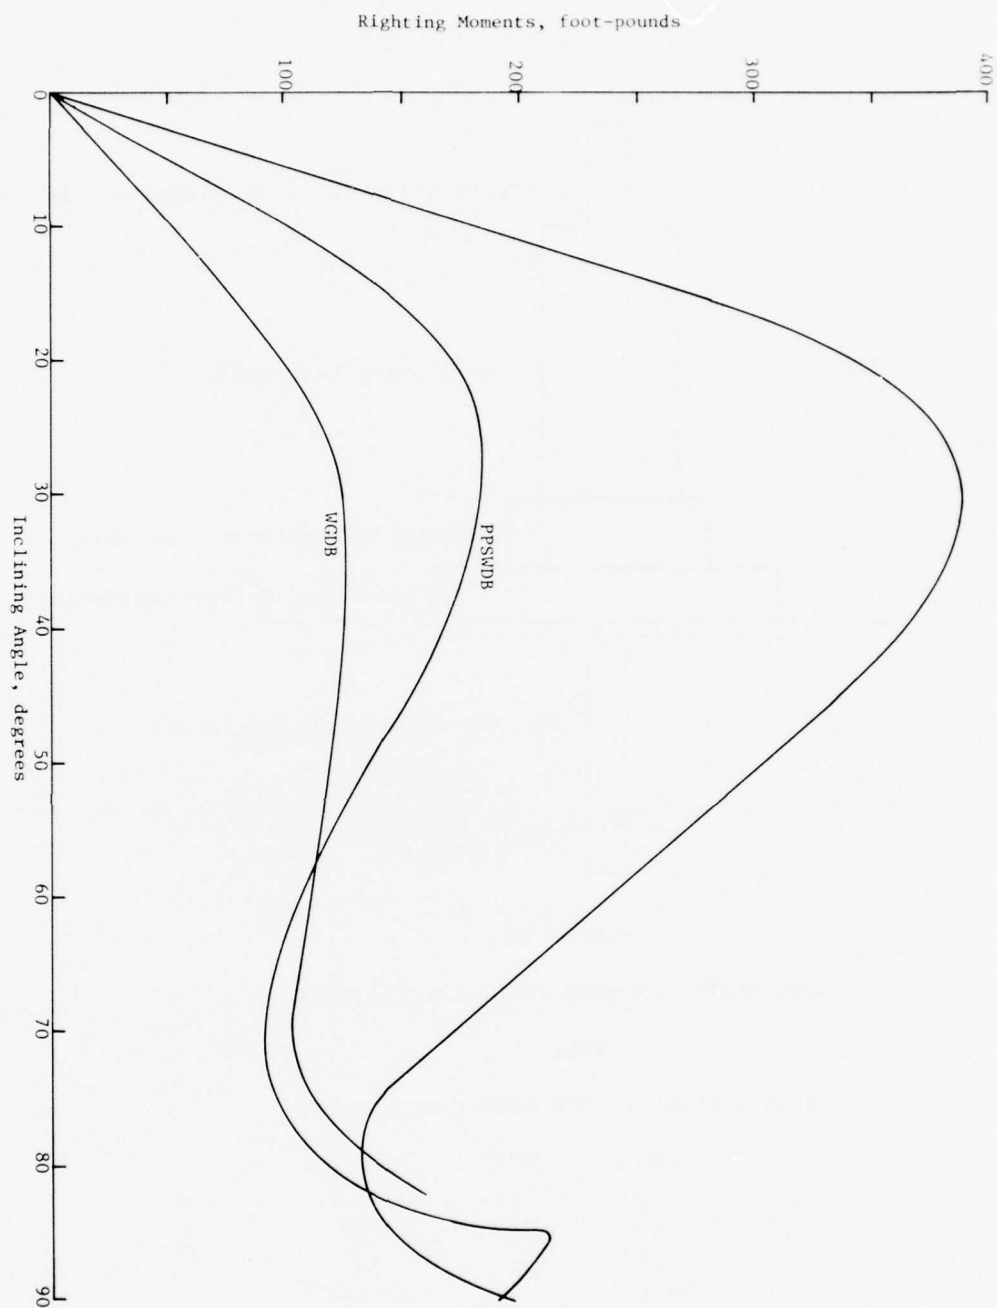
FIGURE 23  
RIGHTING MOMENT CURVES FOR THE WGDB, PPSWDB, AND PPEWDB BUOYS

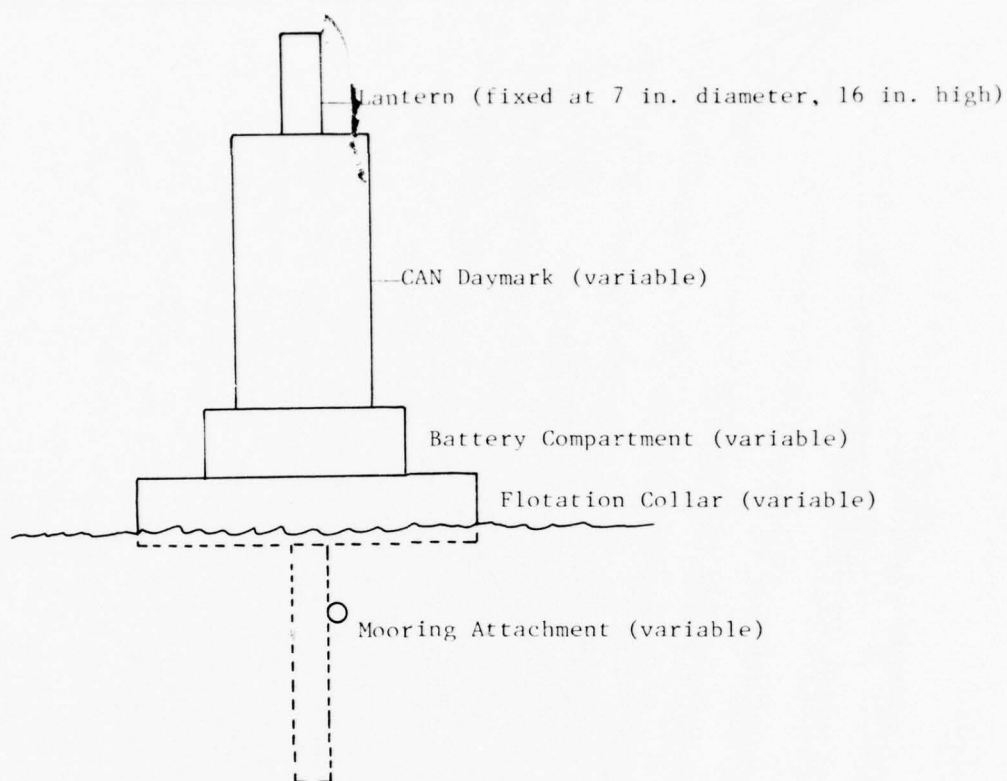
FIGURE 24

BUOY SHAPE FOR WIND FORCE CALCULATIONS

Net horizontal force and the overturning moment caused by the wind were calculated by using the standard drag equation with a coefficient of drag of 1.2 and the maximum projected area of the can. The overturning moment was taken about the mooring attachment points (bridle for the pre-prototype buoys). The wind force and resulting overturning moments initially decreases as a cosine function as the angle of list increases from zero to a point where the flotation collar rises into the wind stream. Thus, the cosine approximation is not accurate at high angles of list. The buoys were assumed to be of the general shape shown in Figure 24 and dimensions given in Table 5.

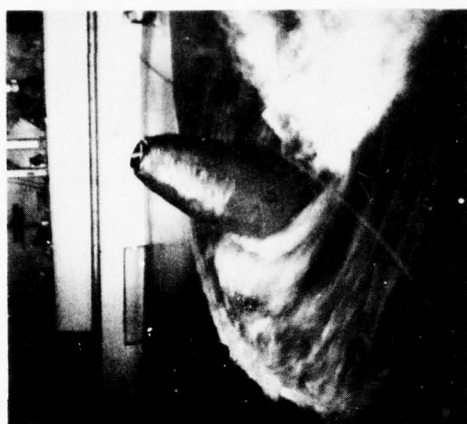
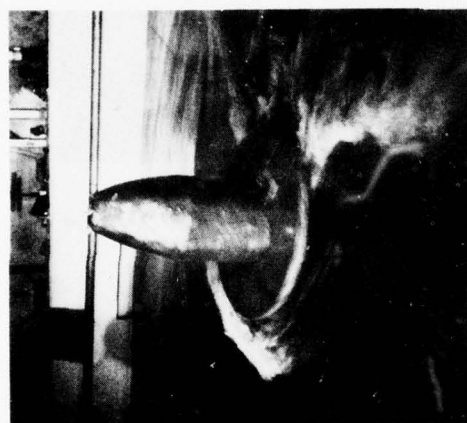
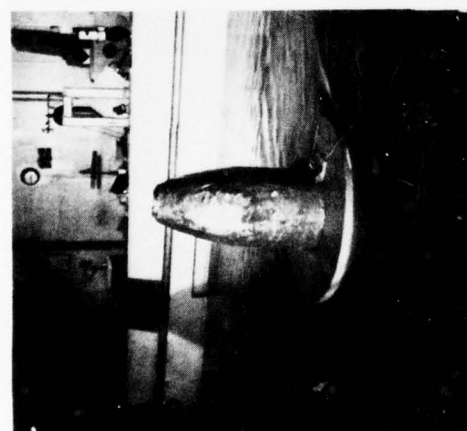
FIGURE 30  
The PPSWDB in a current of 3 knots showing a significant trim forward (a). The same buoy with a lower attachment point is shown (b) in a current of 5 knots prior to capsizing (c and d). Note that the counterweight tube is above the mooring cable after capsizing (d).

g. The pre-prototype buoy's trim was very sensitive to the location of the attachment point on the center tube. When the attachment point was too high, the hull would plow through the water and would not have an angle of attack that would provide dynamic lift from the underside of the hull (shown in Figure 30a). When the attachment point was too low, the buoy would trim severely aft (shown in Figure 30b) and on the PPSWDB causing a stall of the dynamic lift and subsequently, the buoy would capsize. In the capsized position the mooring attachment point is below the counterweight tube as shown in Figures 30c and d. The best mooring attachment point positions were 17.5 inches and 25.5 inches below the hull for the PPSWDB and PPEWDB, respectively.

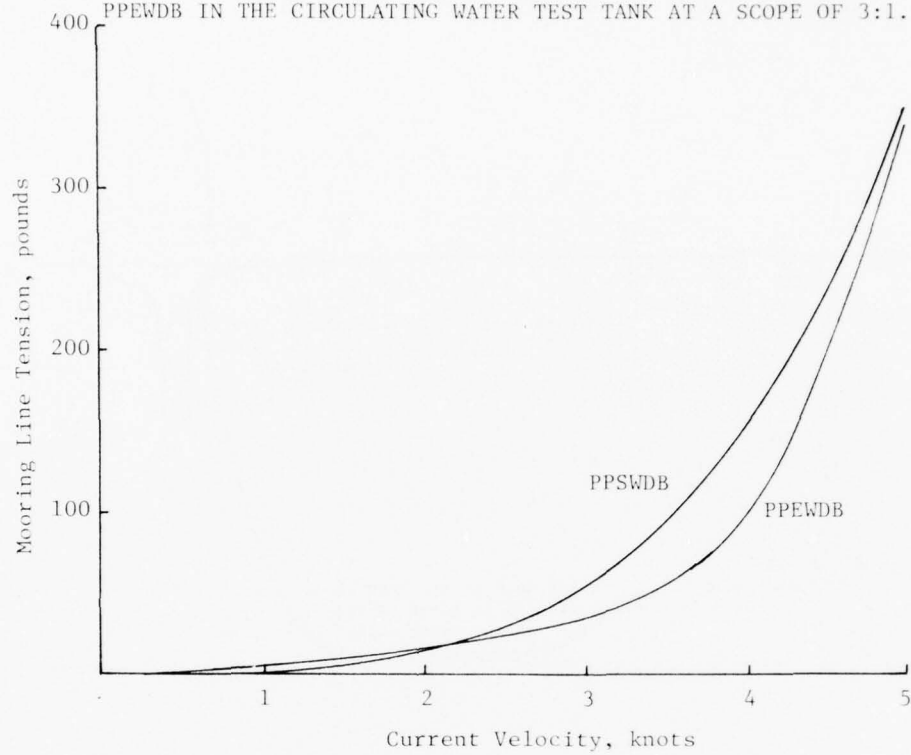
THE MEASURED MOORING LINE TENSIONS OF THE PPSWDB AND  
PPEWDB IN THE CIRCULATING WATER TEST TANK AT A SCOPE OF 3:1.

i. Example PPSWDB and PPEWDB mooring line tensions are shown in Figure 31.

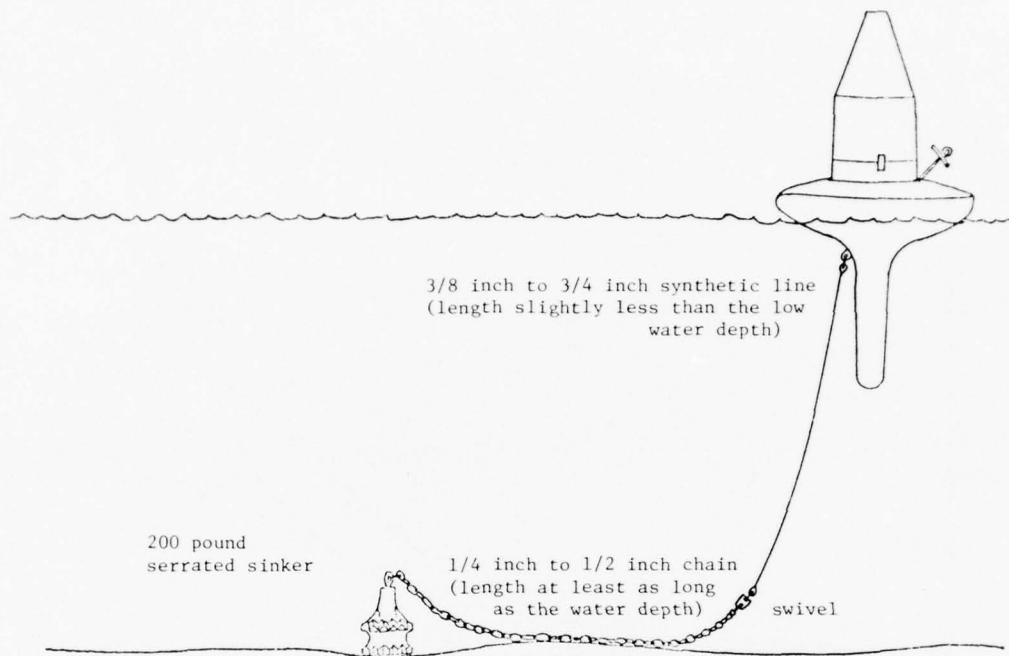
FIGURE 32a  
MOORING SYSTEM FOR SHELTERED WATER ENVIRONMENT

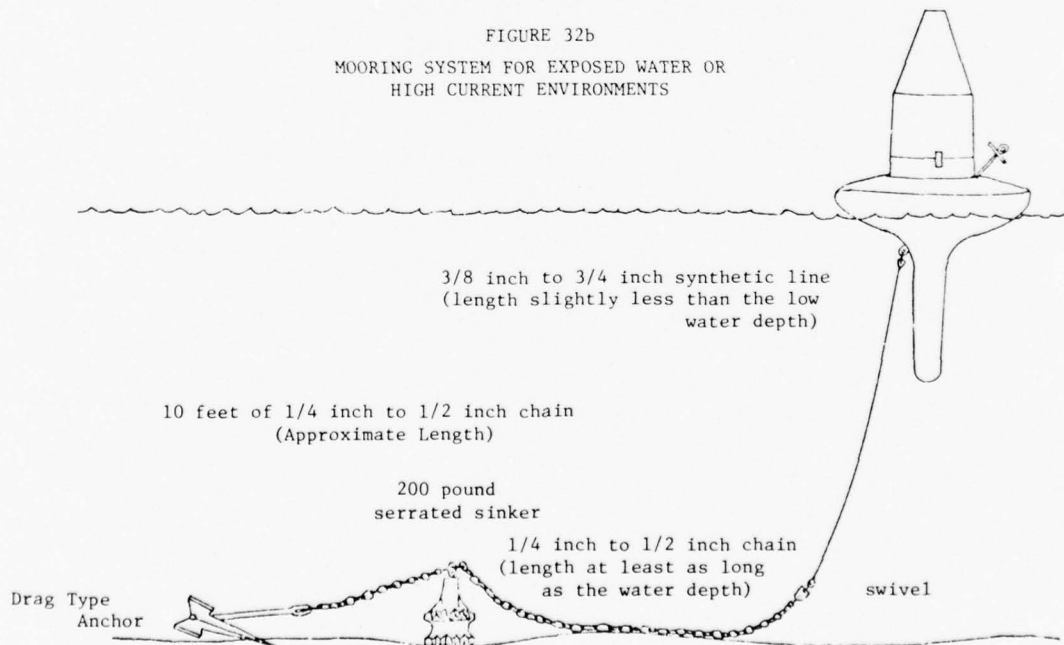
FIGURE 32b  
MOORING SYSTEM FOR EXPOSED WATER OR  
HIGH CURRENT ENVIRONMENTS
